MECHANISMS OF CAVITATION DAMAGE STUDIES USING SOFT ALUMINIUM

SOBEIH M.A. SELIM*

ABSTRACT

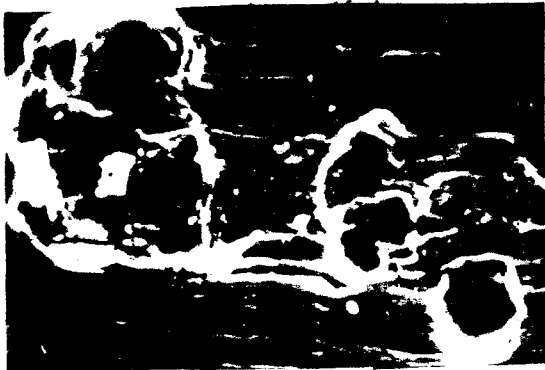
Fig.3.

Figs. 3 and 4. Overlapping many dents to form large craters(x100)

All specimens exposed to cavitation have been studied by optical microscope. These investigations reveal that right from the beginning of cavitation exposure plastically deformed areas occur on the originally smooth surface. During the first part of the cavitation exposure the deformed areas are clearly separated indicating that each of them is caused by the collapse of a single cavity. If specimens are exposed to cavitation for different times but at a fixed cavitation condition, the maximum number of dents per mm^2 is expected to increase proportional to exposure time. This is verified by counting the number of dents in small square (2 x 2 mm) over the central area of the eroded specimen during the first part of the exposure time. The same trend was reported by Knapp [10], Hanson and Mørch [11] and Lobo Guerrero [12]. At further cavitation exposure the dents are found to start overlapping, and a highly distorted surface develops with deformations of larger scale. The density of pits reaches a maximum when overlapping becomes significant and a further cavitation exposure the density of dents falls to a somewhat lower but constant level. This is shown in Fig. 2, which covers exposure time up to 300 sec. The reason that the dents density reaches a maximum and then becomes constant is due to the interface of the damage areas and transformation of the overlapping dents into one large crater

by a new cavity collapse in between them as shown in Figs 3 and 4.
